**CALIFORNIA REGIONAL WATER QUALITY CONTROL BOARD - SAN DIEGO REGION  
WATERSHED MANAGEMENT PROGRAM**

**FACILITY INSPECTION REPORT**

**INSPECTION DATE:** 22 May 2006

**FACILITY:** Carlsbad Municipal Golf Course

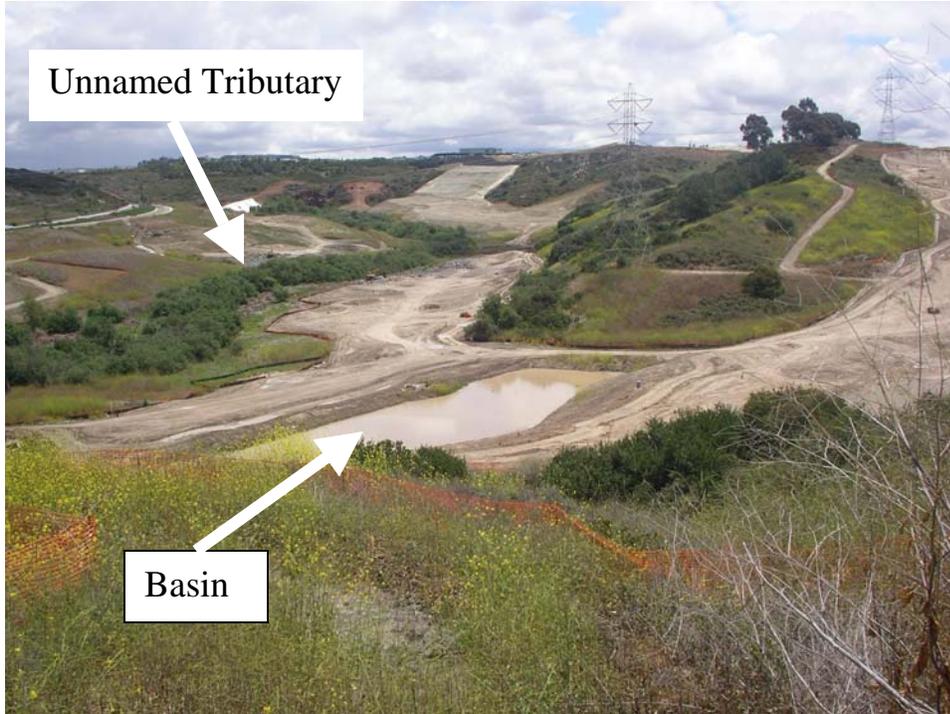
IMGP0229.JPG

**IMGP0229.JPG** looks to the east as seen just east of the construction trailer on Hidden Valley Road. The main sediment detention basin can be seen in the middle of the photograph. The basin is full of runoff from today's early morning storm event. An unnamed tributary runs from the upper middle of the photograph to the left center.

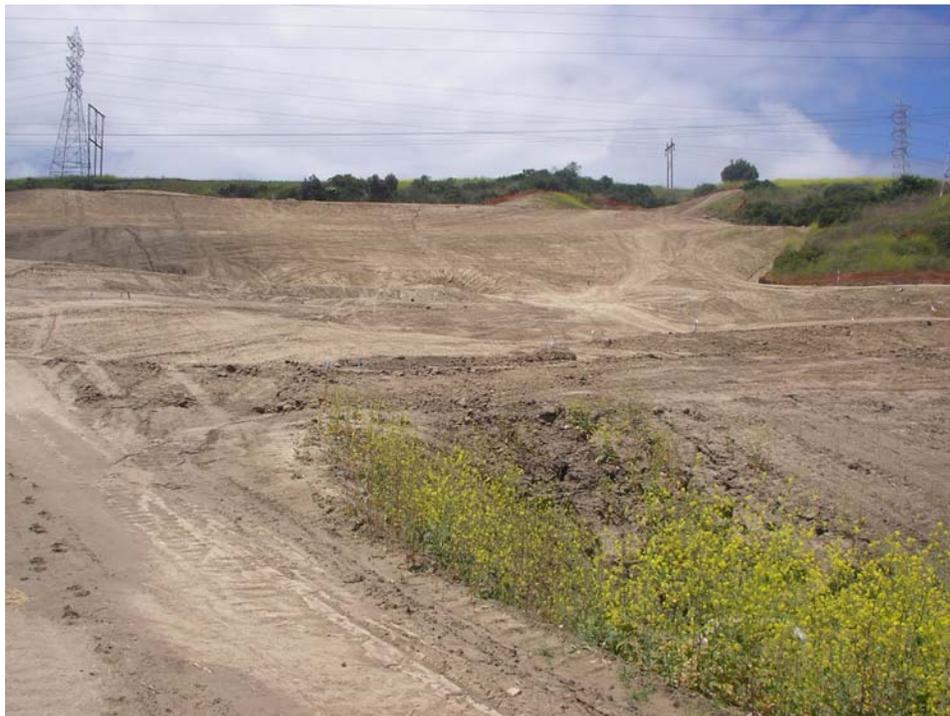
IMGP0231.JPG

**IMGP0231.JPG** looks to the west from the sediment detention basin. Although there is a large expanse of unprotected steep slopes, very little erosion was noted.

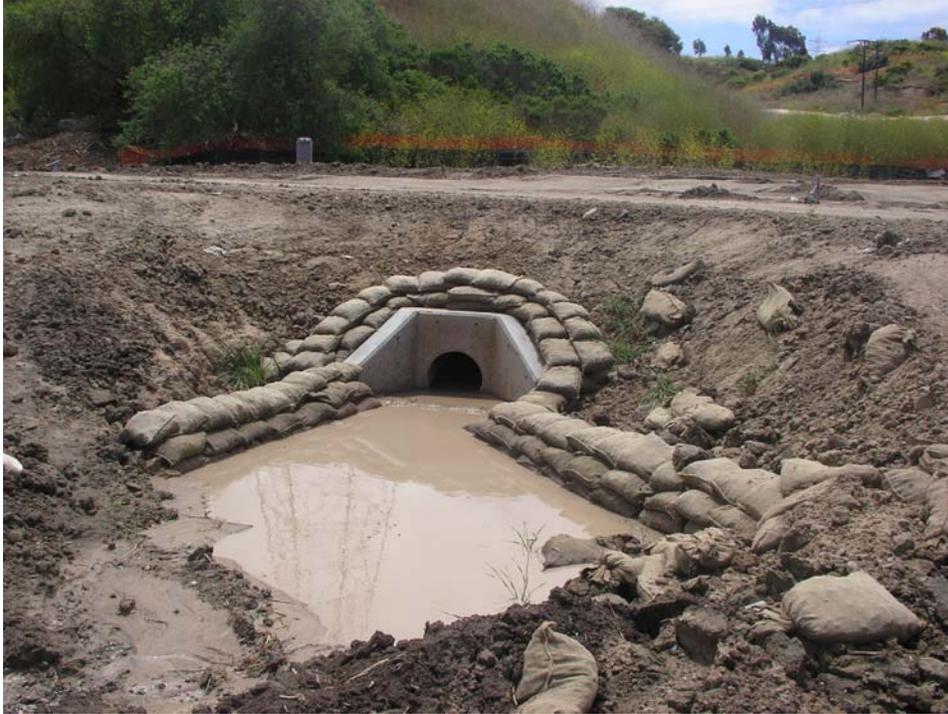
IMGP0234.JPG

**IMGP0234.JPG** looks to the southwest at the sediment basin outlet. Although the flow is highly turbid, the flow spreads out over a relatively flat vegetated expanse and does not appear to discharge into the unnamed tributary. The BMP appears to be working effectively.

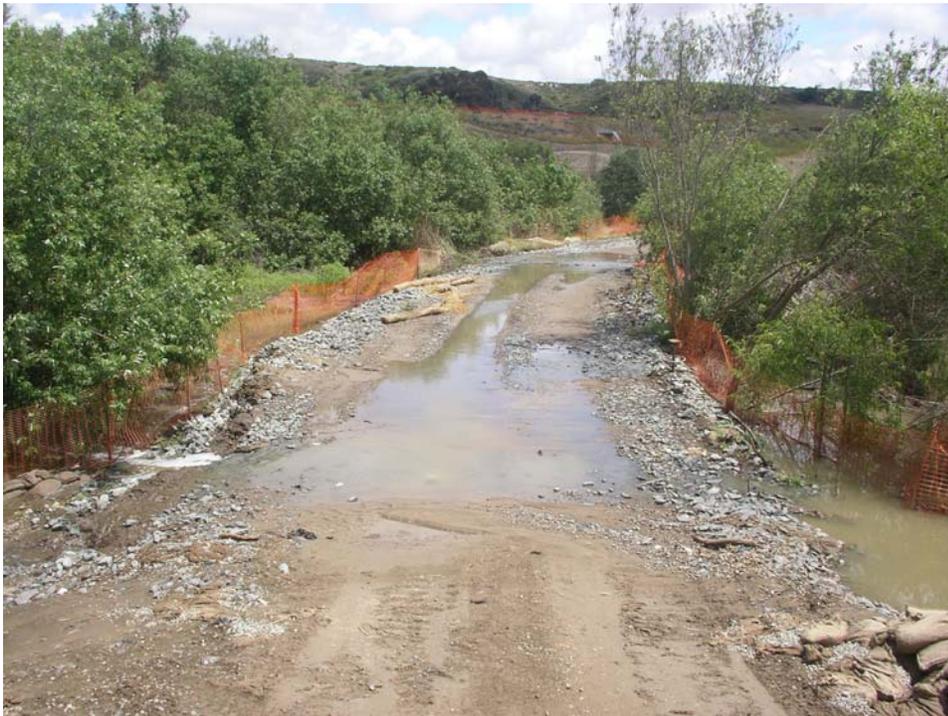
IMGP0235.JPG

**IMGP0235.JPG** looks to the east at the unnamed tributary flowing across a dirt road just northeast of the sediment basin. A substantial flow can be seen running across the dirt road as a result of this early morning's storm event. The water was slightly turbid, but generally appeared to be clear.

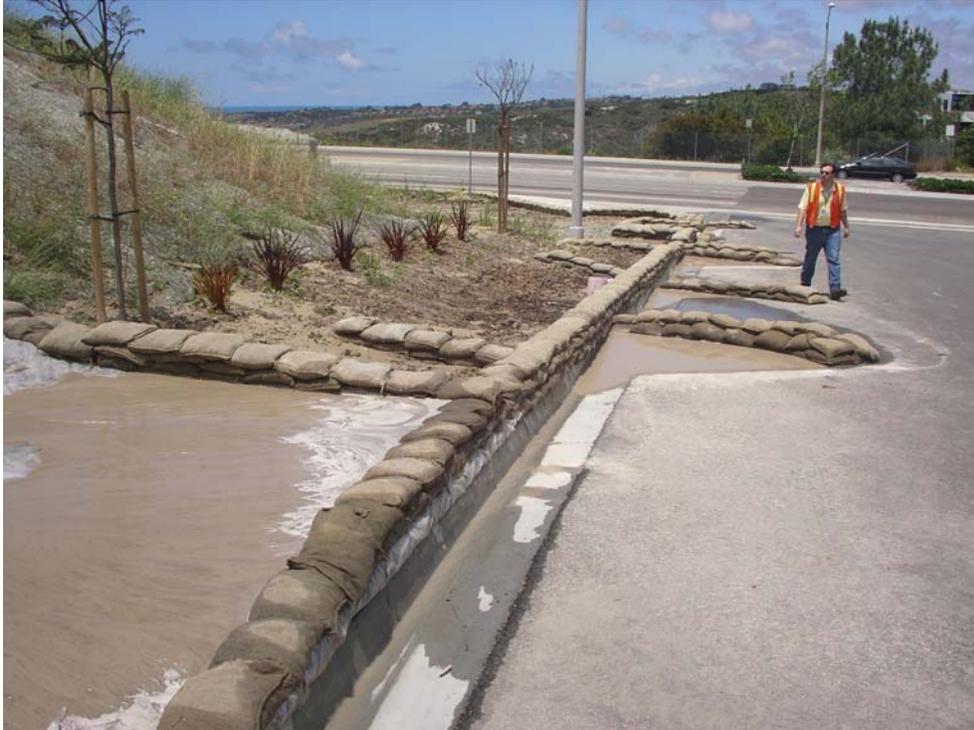
IMGP0239.JPG

**IMGP0239.JPG** looks to the north along Palomar Point Way onto College Blvd. Runoff laden with sediment can be seen flowing off of the slope, into the gutter and around gravel bag check dams. Dried sediment indicates that the flow had been greater earlier in the day.

Cease the sediment discharge, cleanup the sediment where possible, notify the Regional Board in writing that the discharge has ceased, including how this was achieved, maintain BMPs, monitor weather conditions, and update and implement SWPPP changes as field conditions change.

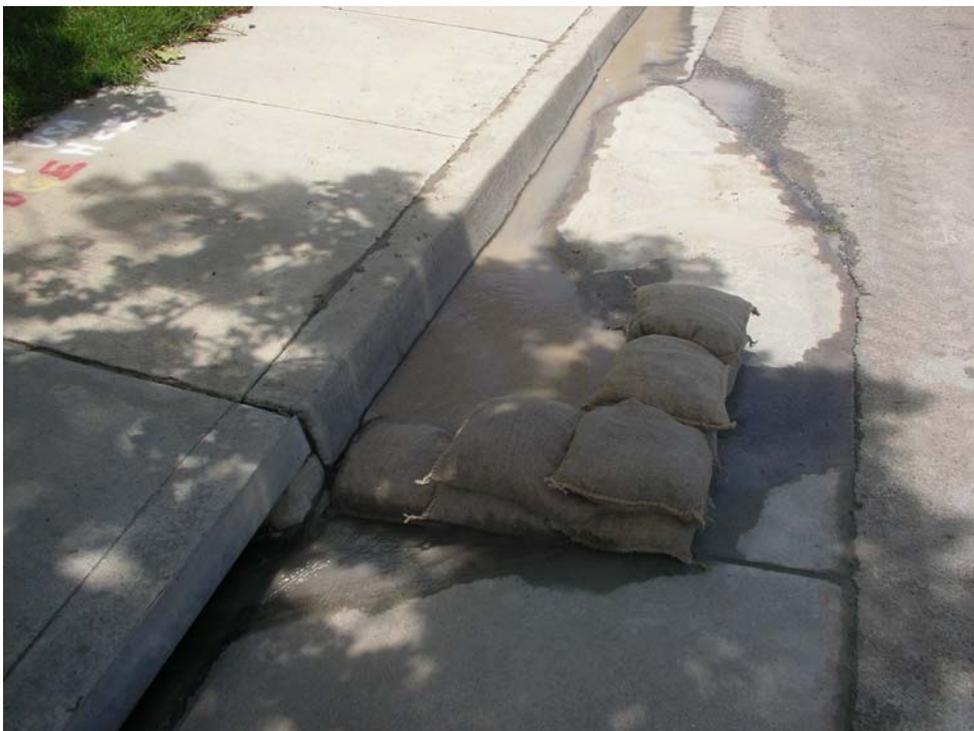
IMGP0242.JPG

**IMGP0242.JPG** looks to the west along College Boulevard. Sediment laden runoff can be seen flowing around and through gravel bags into the storm drain.

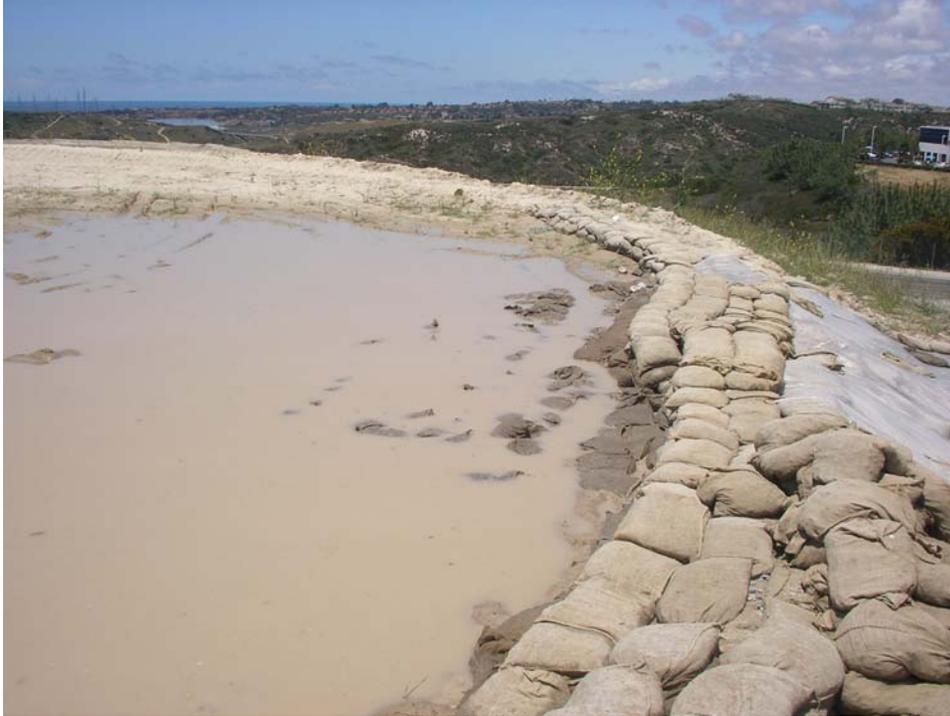
IMGP0243.JPG

**IMGP0243.JPG** looks to the north from the top of a graded pad on the southwest corner of College Boulevard and Palomar Point Way. Water ponded on the pad undercut the gravel bags anchoring the spillway, traveled under the plastic, and discharged onto the Palomar Point Way.

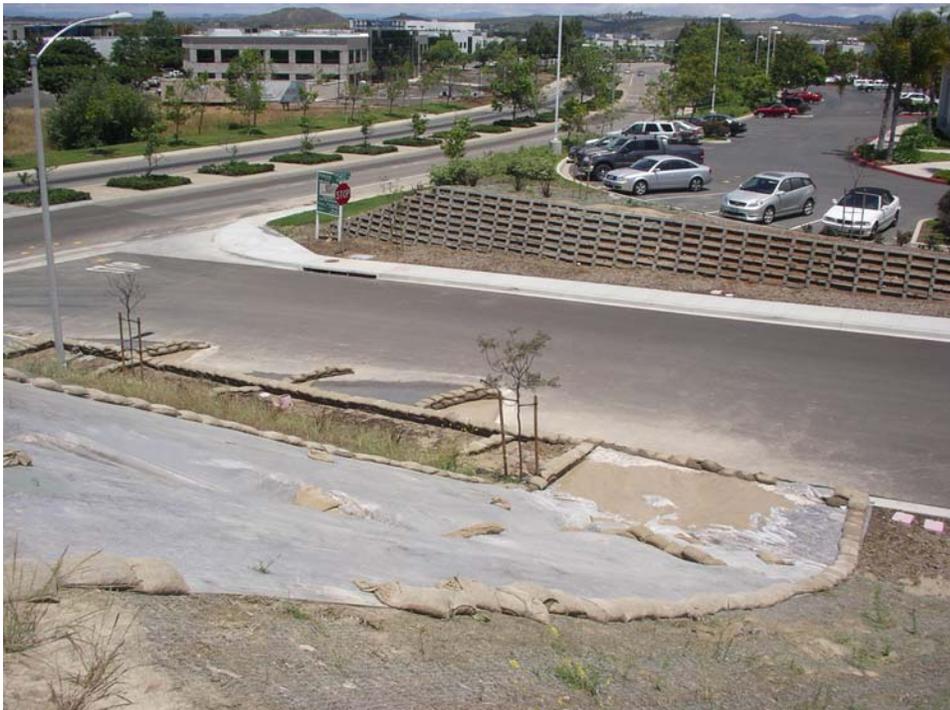
IMGP0244.JPG

**IMGP0244.JPG** looks to the northeast down onto the intersection of Palomar Point Way and College Blvd. Gravel bags were used to anchor the plastic sheet spillway. Sediment stains on the asphalt of Palomar Point Way evidence a greater flow rate earlier in the day.
